Stabilization of a 30 m High Riverbank in Canada with Nails, Plates and Roots

STABILIZATION OF A 30 M HIGH RIVERBANK IN CANADA WITH NAILS, PLATES AND ROOTS

Paper No. 2.66

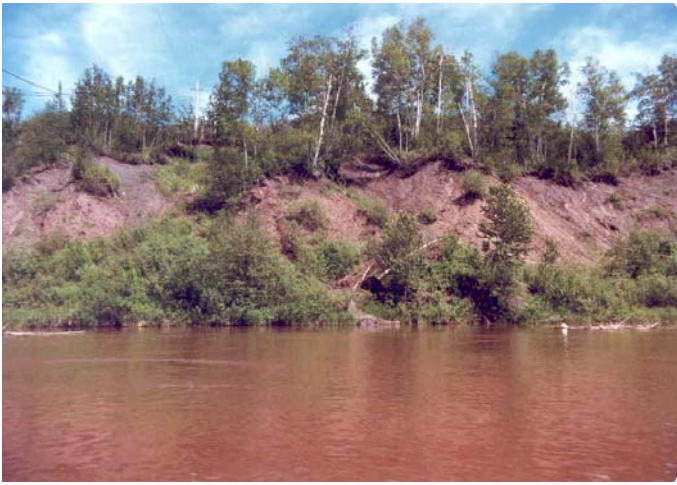
Fig. 2. Active erosion on the Kaministiquia River

The case study of this slope involves the riverbanks along the Kaministiquia River, one of the largest tributaries to Lake Superior. The river meanders through a deeply incised floodplain of the Kaministiquia delta, with 30 m high valley sides (Figure 1). The river travels through an urban area of Thunder Bay, the 10th largest city in Ontario, on the shore of Lake Superior. Over recent decades the outside of a meander has encroached on a developed area in one area of the city, creating a hazard for a street, watermain and many houses. The active erosion has created riverbank slopes from 27° in the gullies to 45° at the promontories (Figure 2).

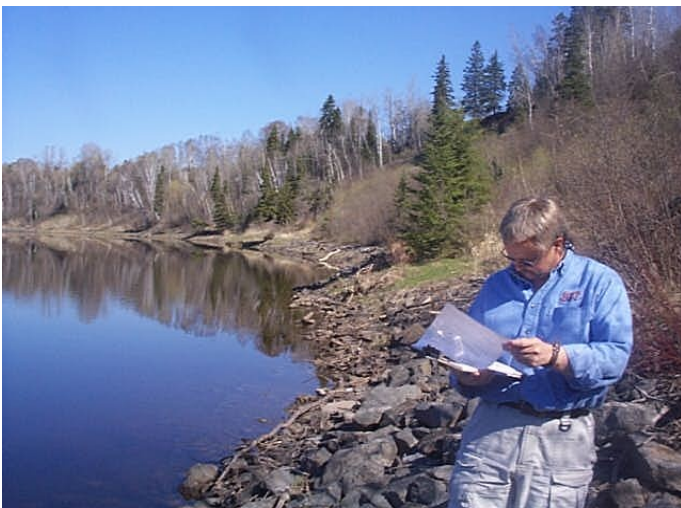
Fig. 3. With the toe erosion arrested, the slope crest continues to regress to its angle of repose.

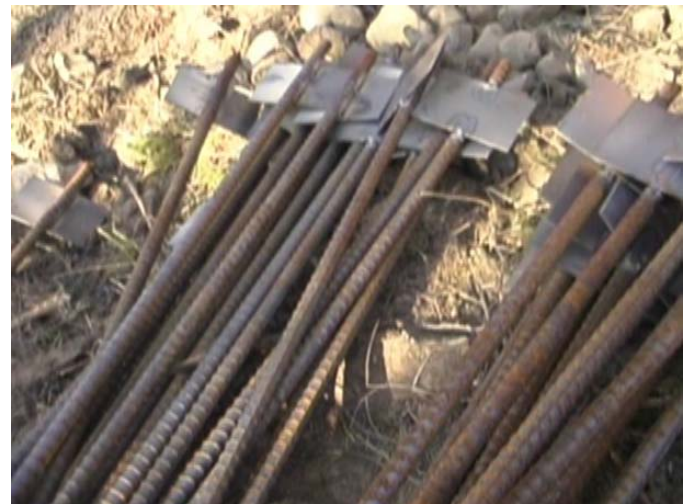
Fig. 10. Soil nails with plate heads

The construction of the SNART system has been described by Fabius et al (2006). The soil nails were installed using small equipment working on the slope (Figure 10). This spider-like walking excavator has 4 legs (2 of which have wheels) and an excavator arm. It can easily work on slopes up to 45°. A

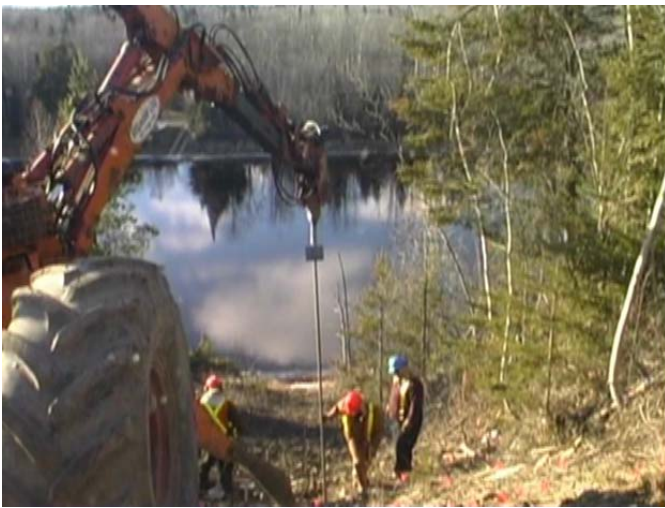
Fig. 11. Rapid installation of soil nails by percussion.

percussion hammer adapted for driving soil nails was mounted on the arm (Figure 11). Minor grade adjustments were made where steep scarps remained.
